Debris/Ice/TPS Assessment And Integrated Photographic Analysis For Shuttle Mission STS-50

DEBRIS/ICE/TPS ASSESSMENT
AND
PHOTOGRAPHIC ANALYSIS
OF
SHUTTLE MISSION STS-50

June 25, 1992

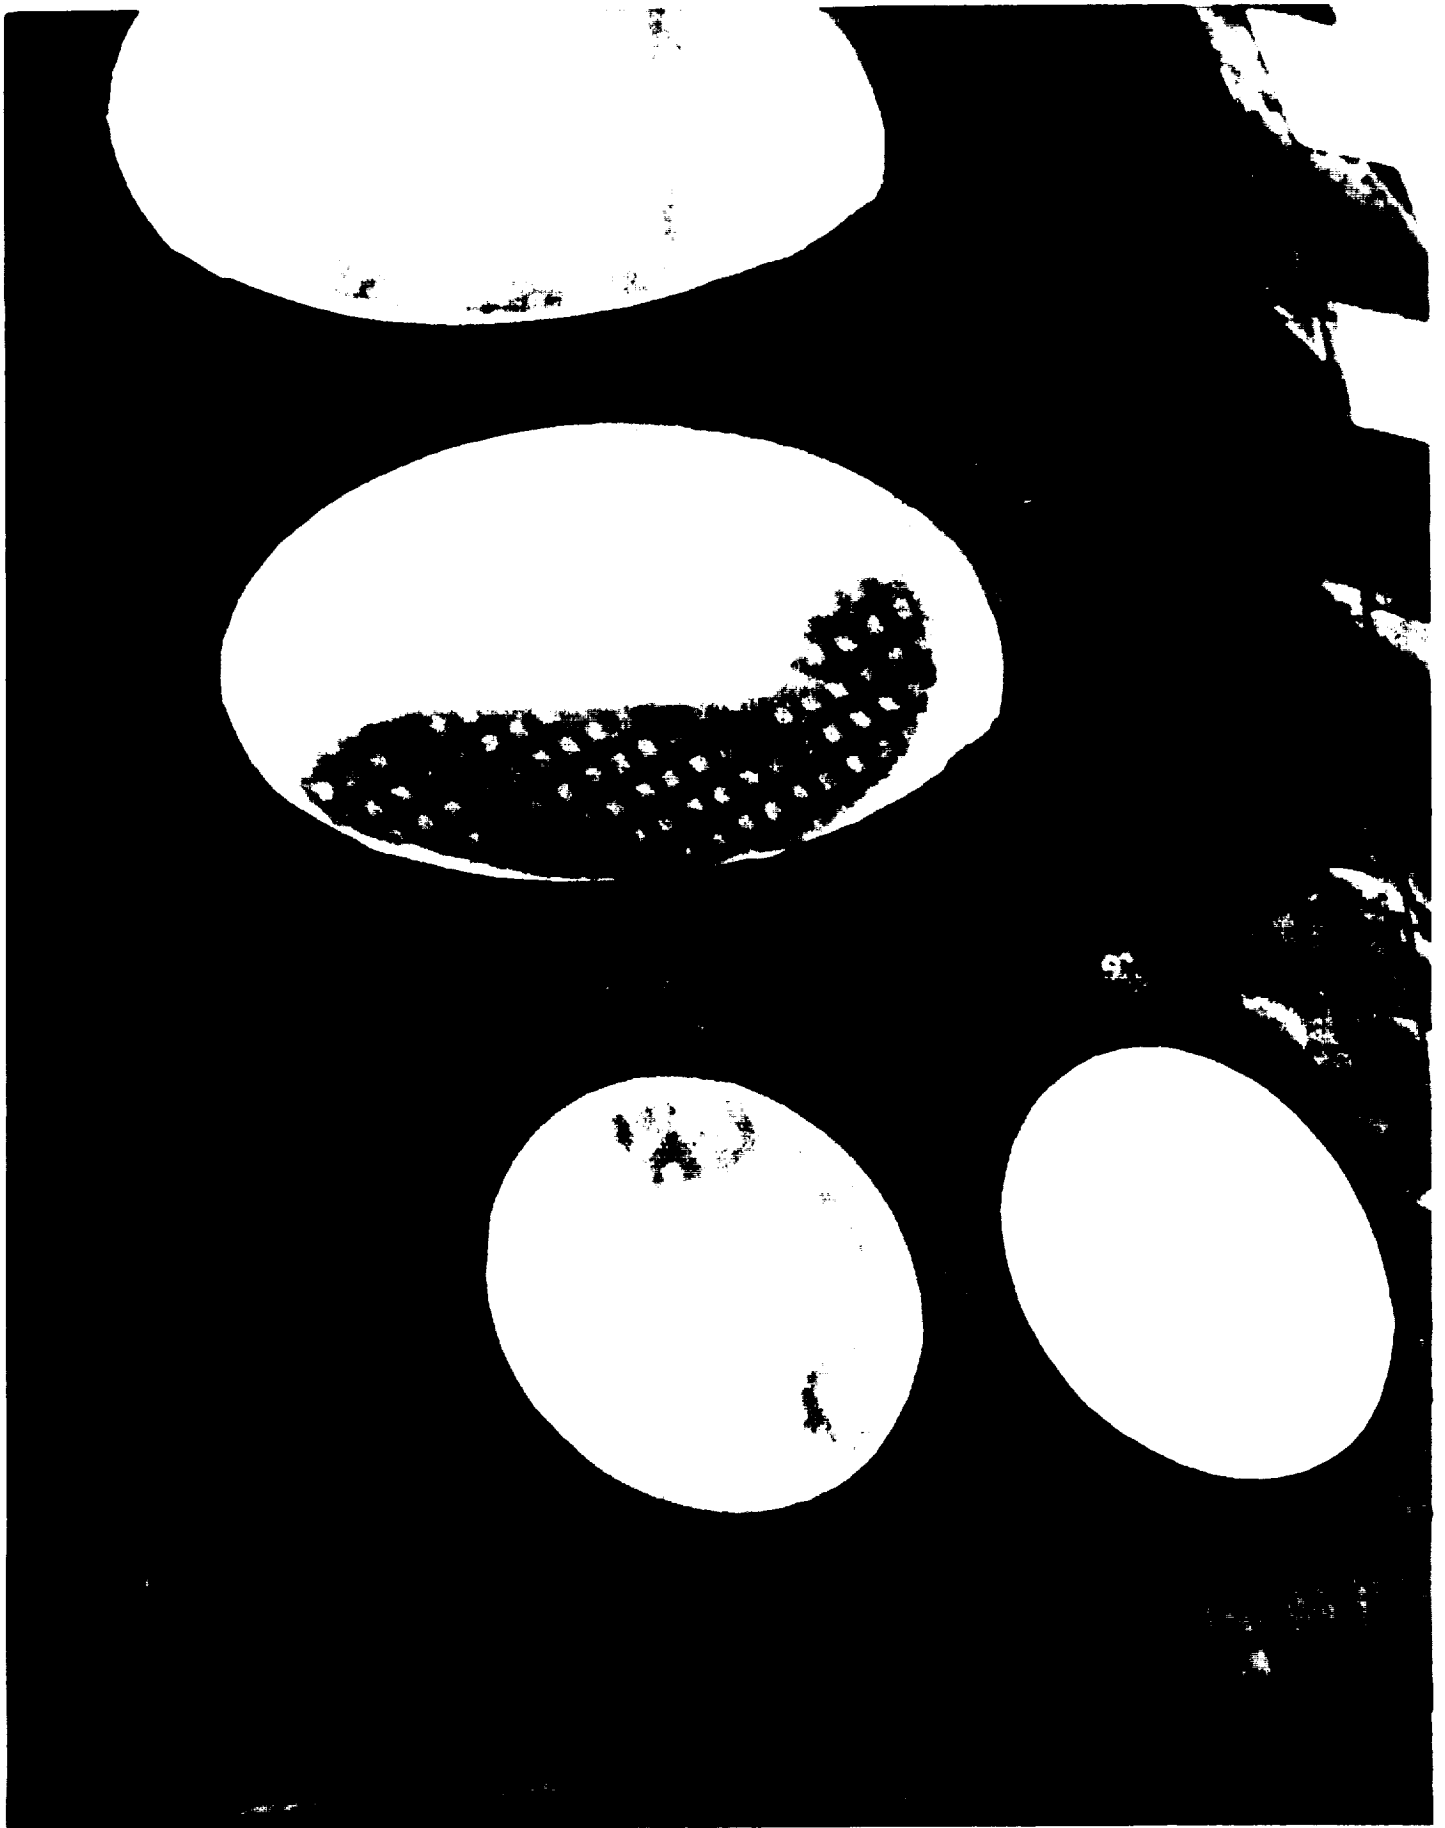
The LH forward RCS thruster paper covers were wet, but intact

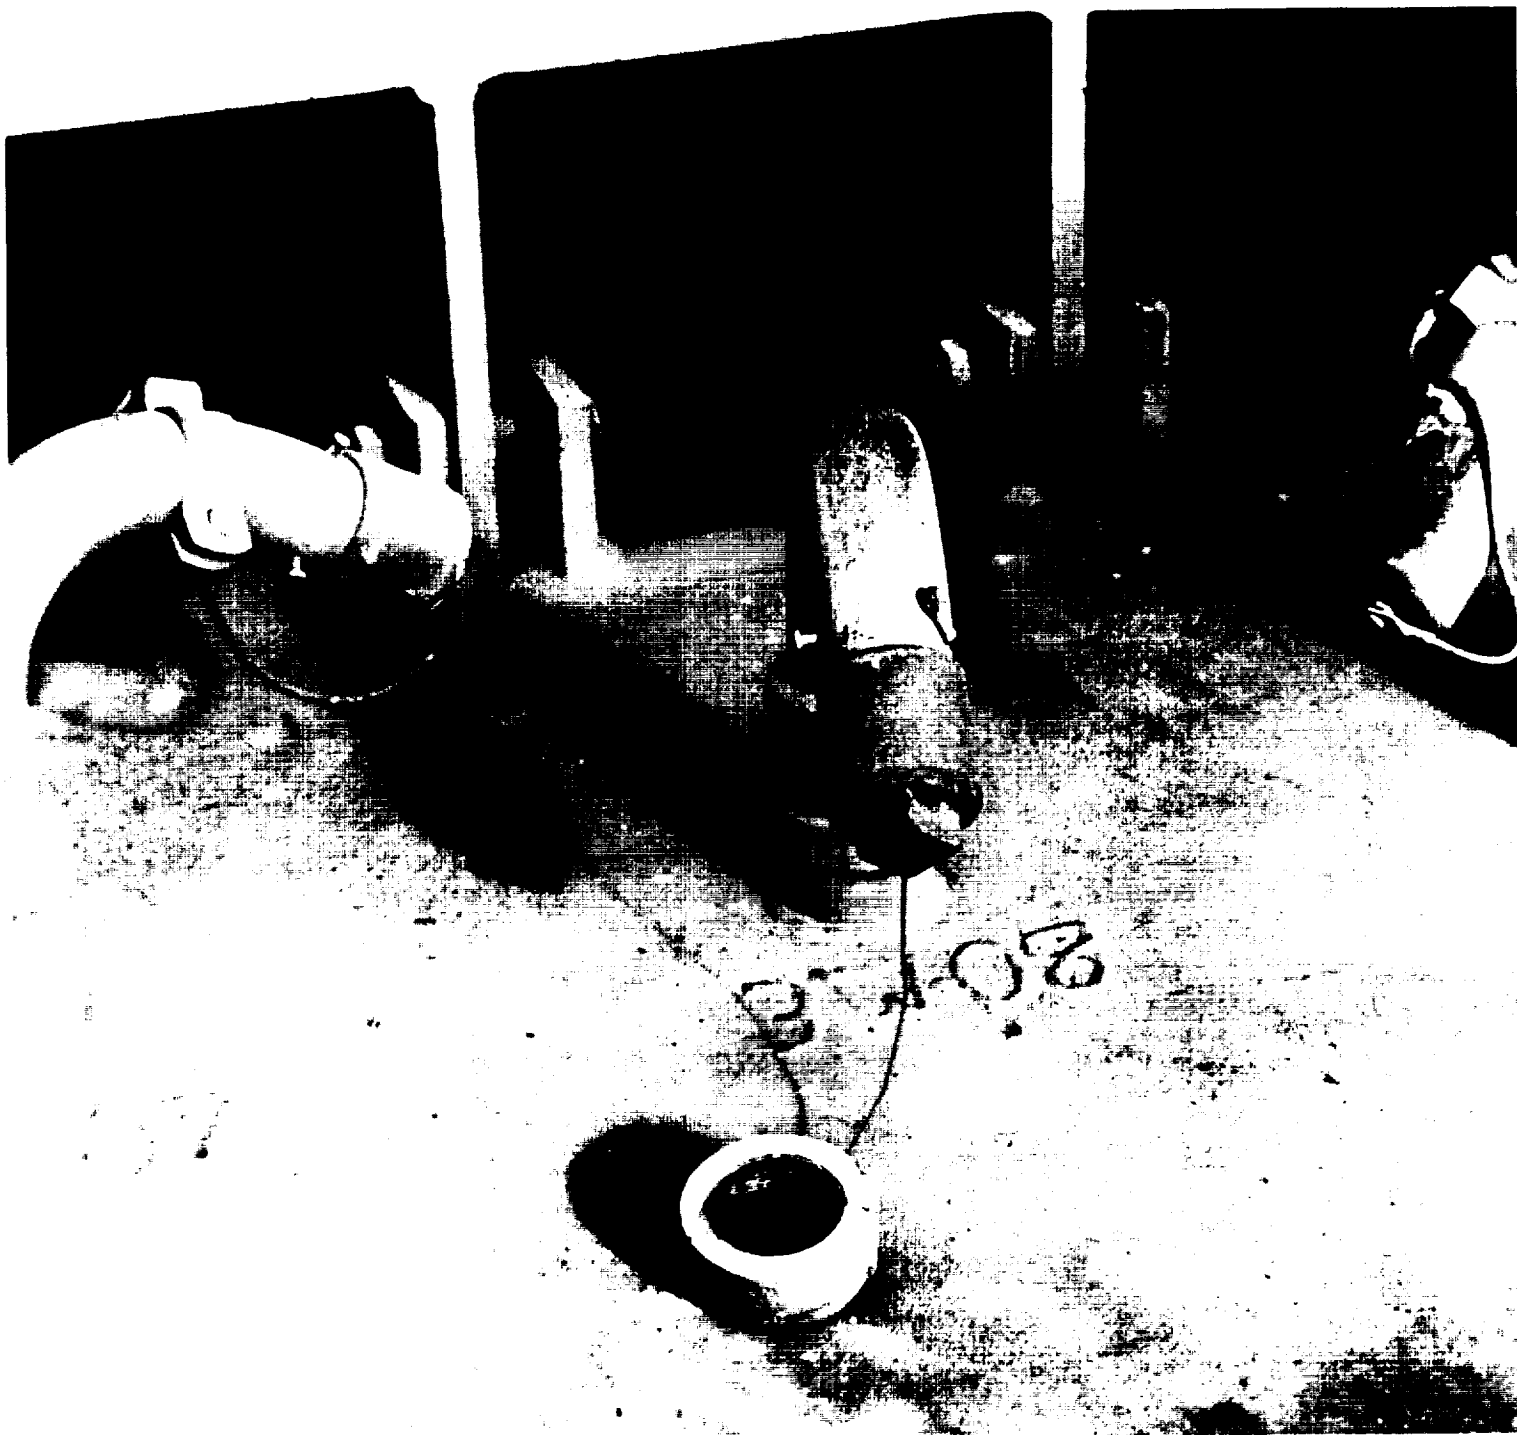
All SRB sound suppression water troughs were filled and properly configured for launch. There was no debris on the MLP deck or in the SRB holddown post areas with the exception of a loose electrical conduit cap on the east side of the SSME flame exhaust hole.

A loose electrical conduit cap on the east side of the
SSME flame exhaust hole was removed

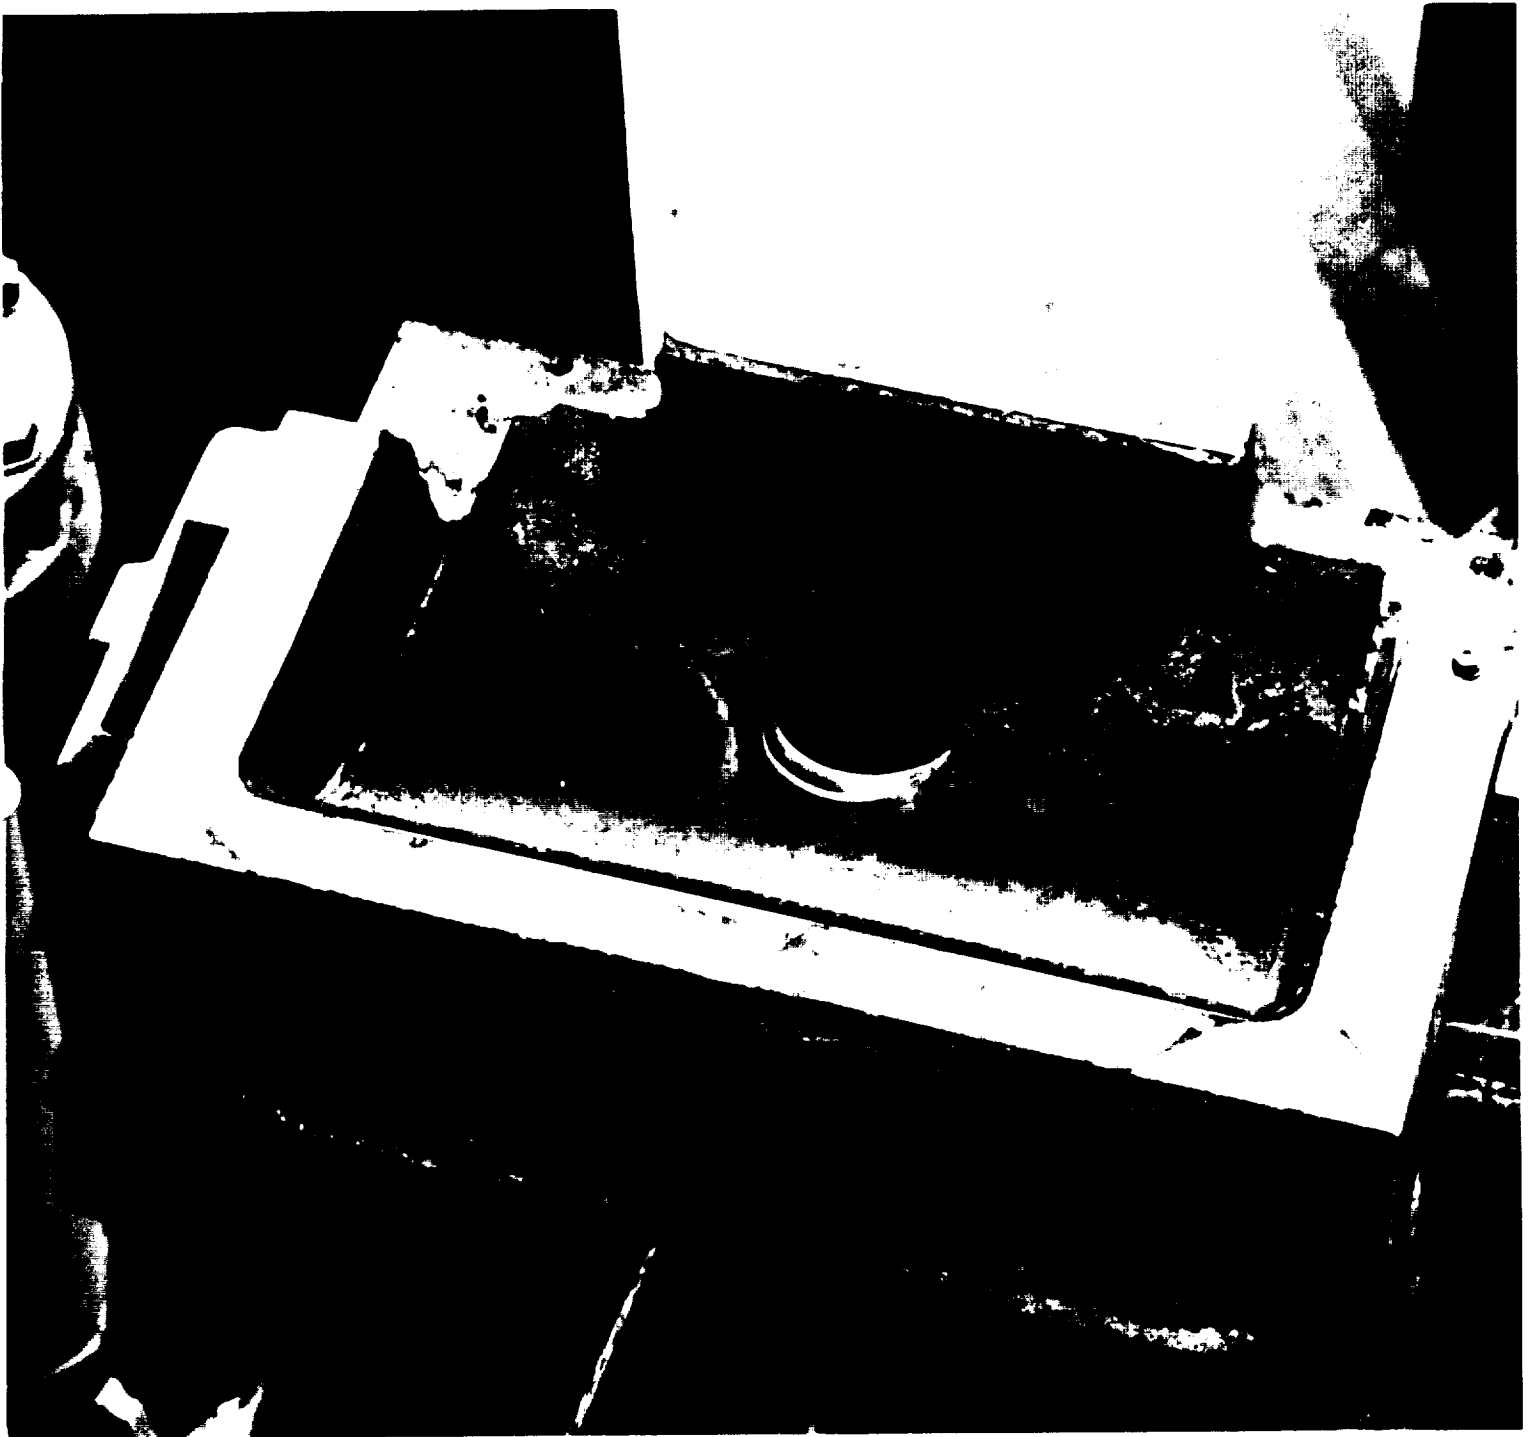
Plume erosion of the south SRB holddown posts was typical. EPON shim material was intact, but debonded along the sidewalls.

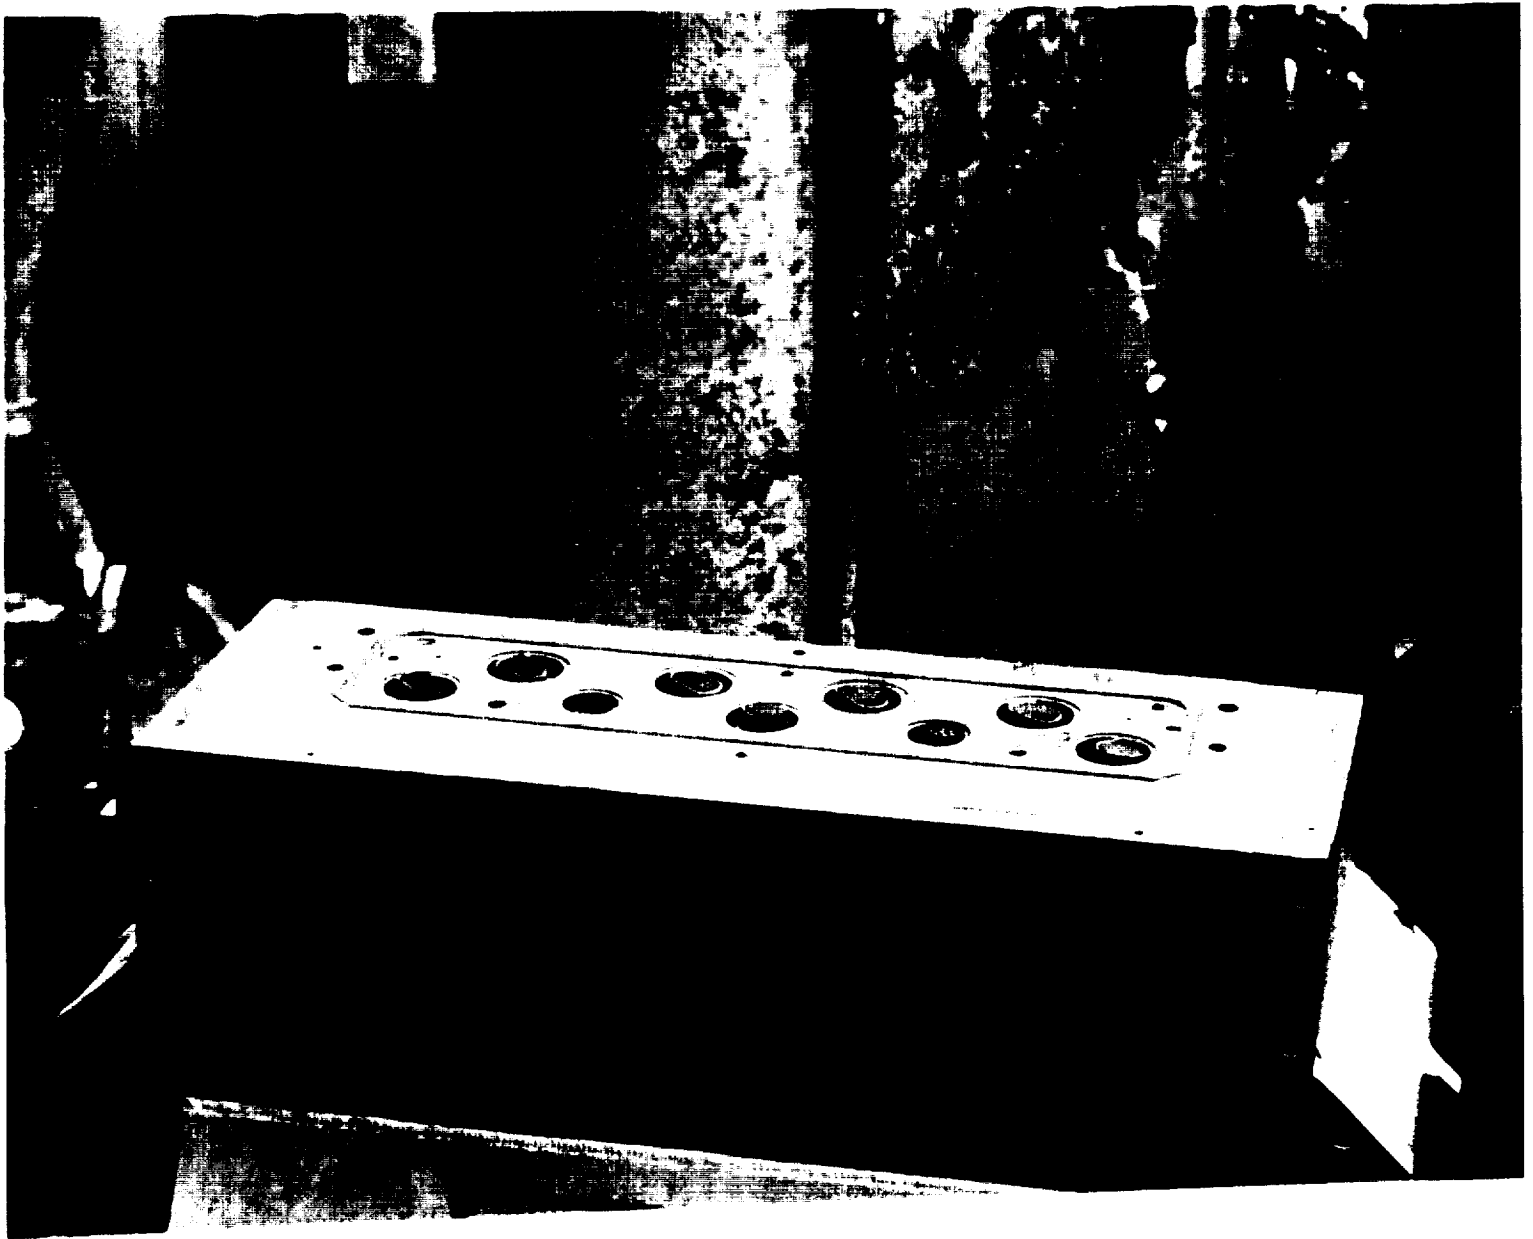
The SRB T-0 umbilicals sustained minor damage

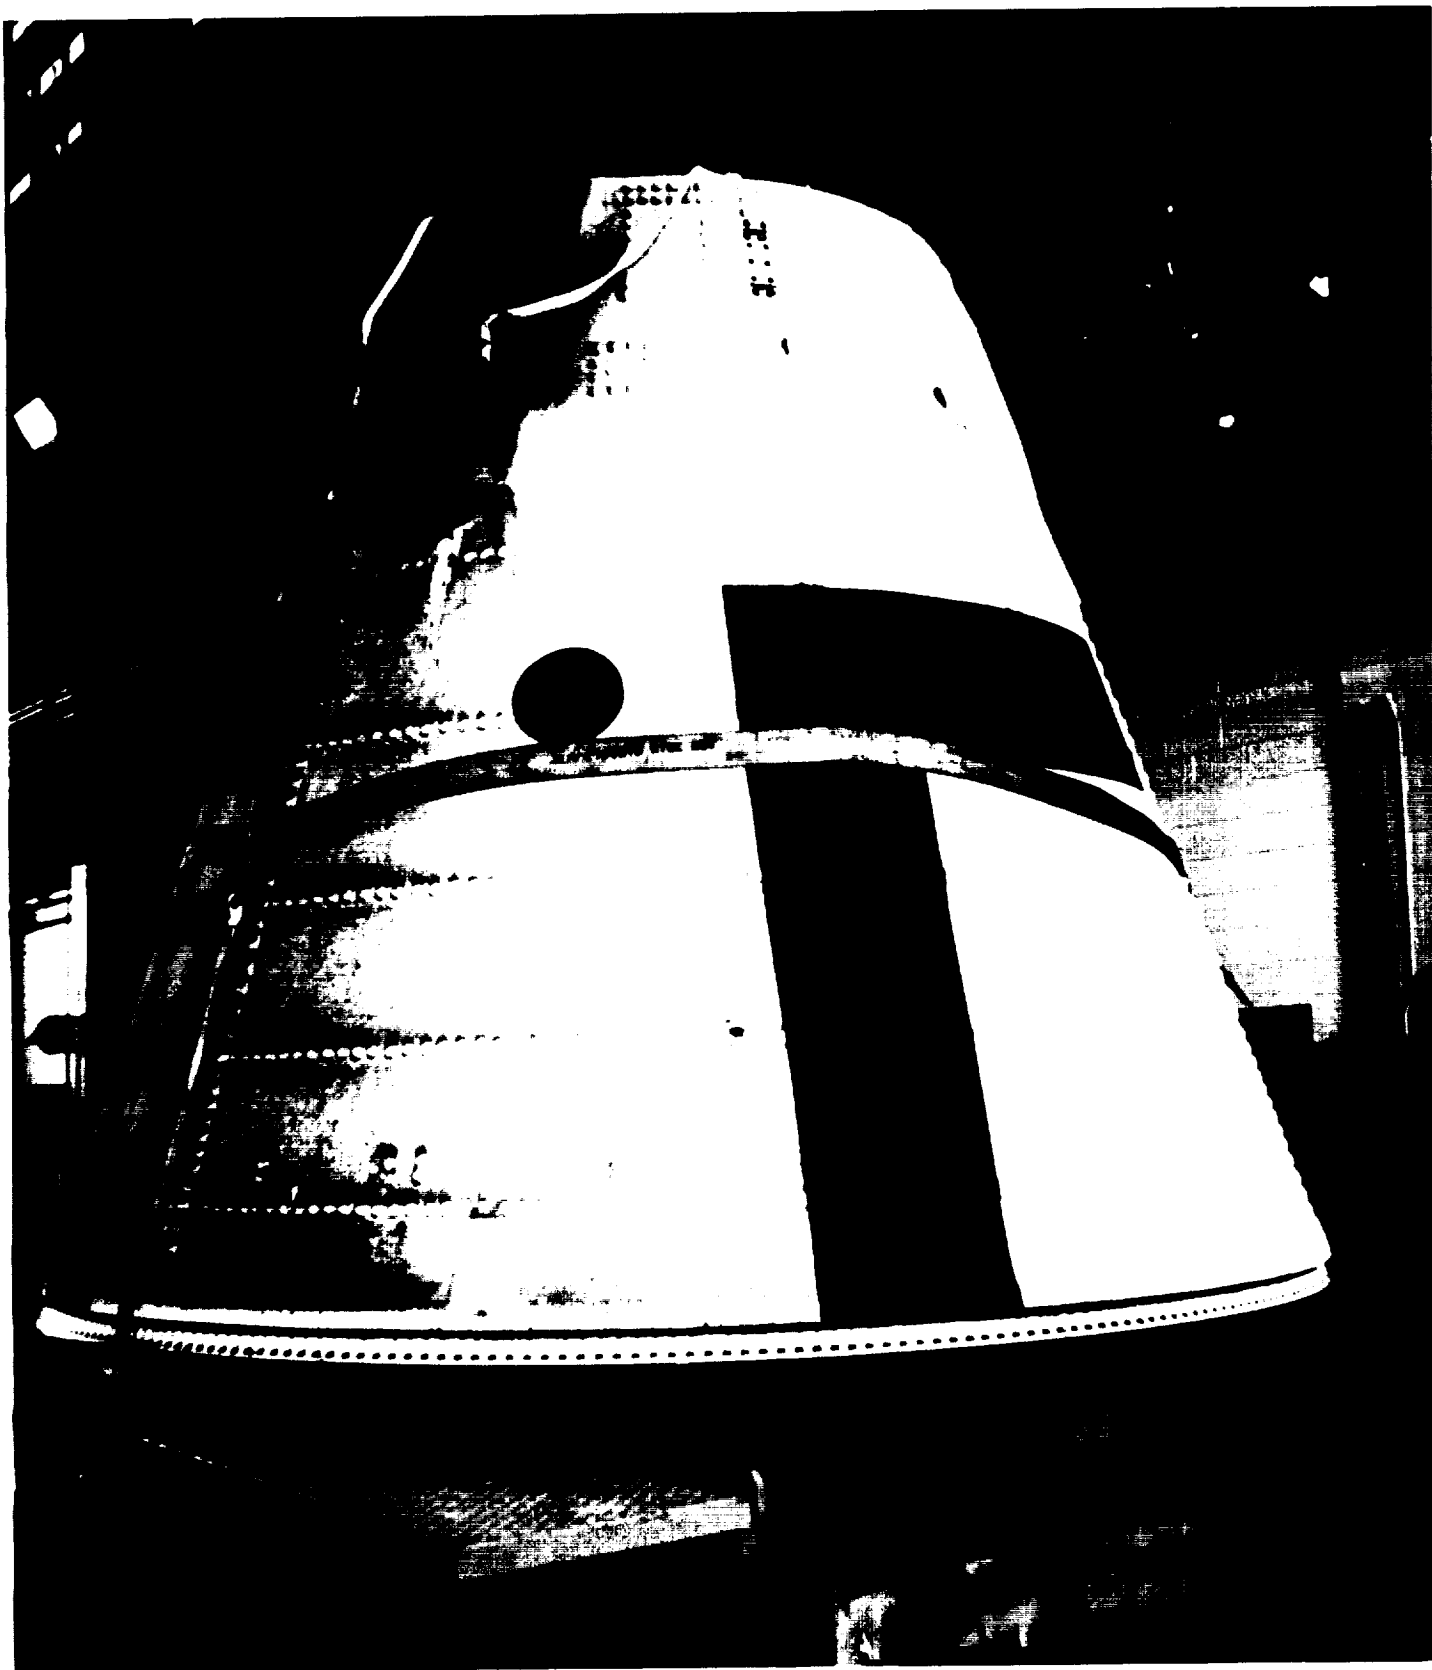
The RH frustum was missing no TPS but had 26 MSA-2 debonds over fasteners. Minor blistering of the Hypalon paint had occurred along the 395 ring. The BSM aero heat shield covers were locked in the fully opened position.

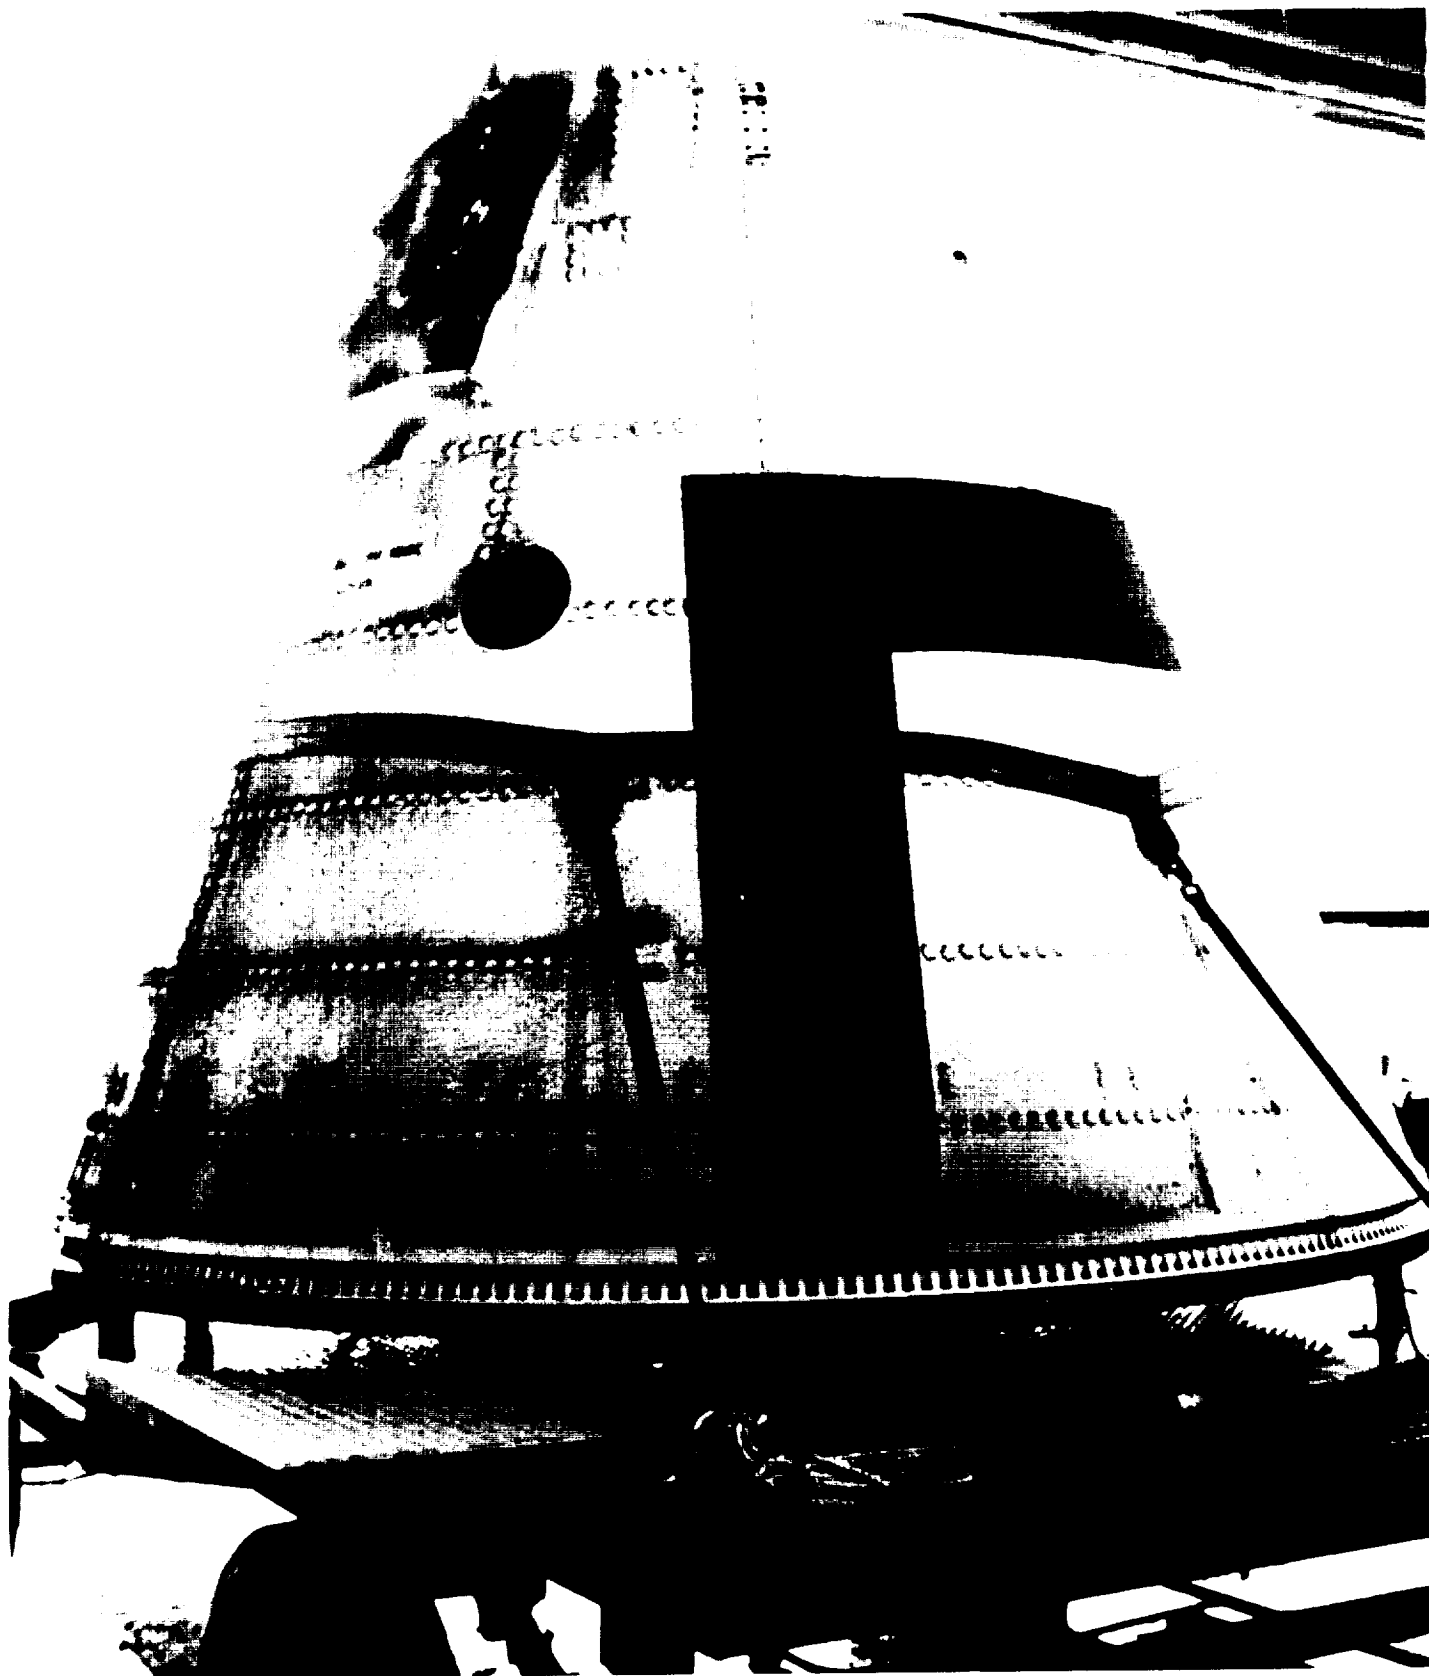
The LH frustum had 15 MSA-2 debonds over fasteners and was missing MSA-2 from one location near the -Z axis. There was minor localized blistering of the Hypalon paint. The BSM aero heat shield covers were locked in the fully opened position, but the two RH cover attach rings had been bent at the hinge by parachute riser entanglement.

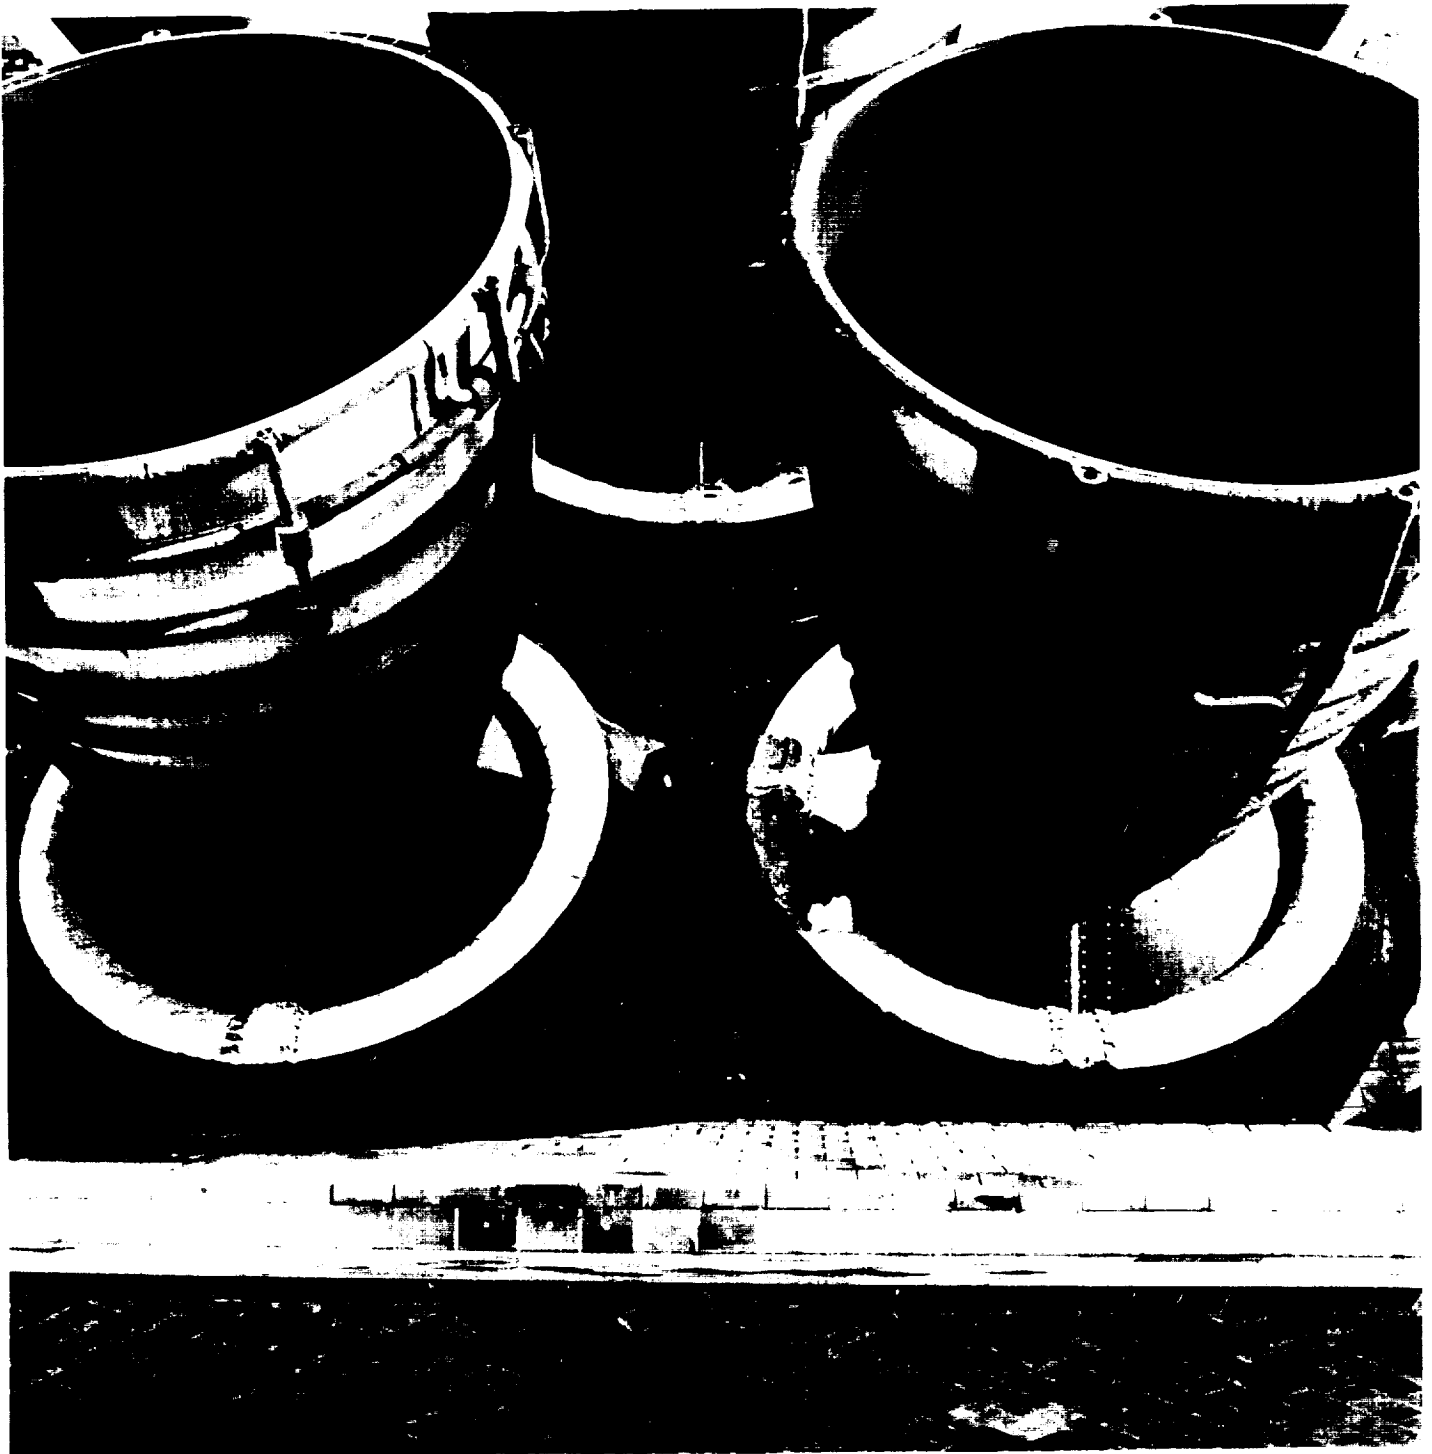
Damage to the base heat shield tiles was less than average. The SSME #3 DMHS closeout blanket was badly torn and frayed from 8:00 to 10:00 o'clock. Two of the sacrificial patches from this area were missing.

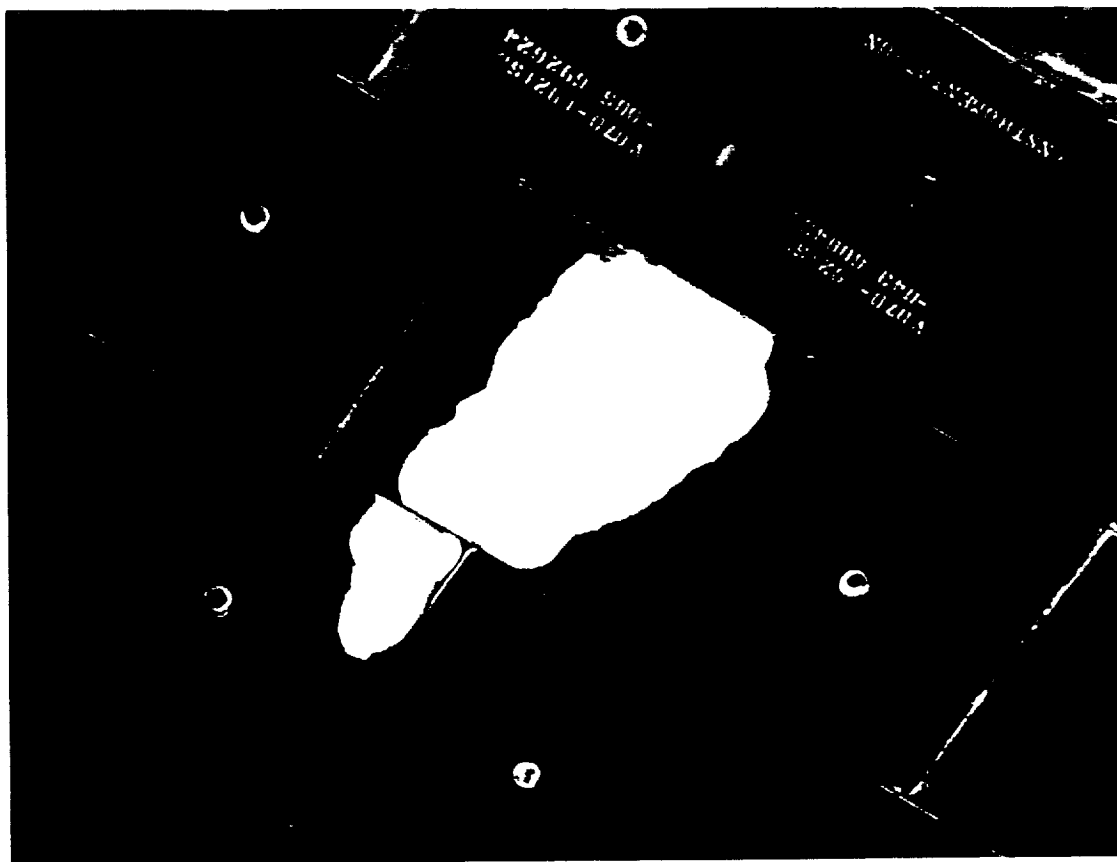
Figure 2.7.4 (A) Large Impact Strike on the Lower Surface of the Orbiter

The post landing walk down of the orbiter revealed that the vehicle sustained a total of 98 strikes, of which 27 had a major axis of greater than one inch. The amount and severity of the impact damage is considered higher than normal and the number of strikes greater than one is higher than normal.
